**SAGINAW MARKING ERRORS REVISITED...by Louis Losi**

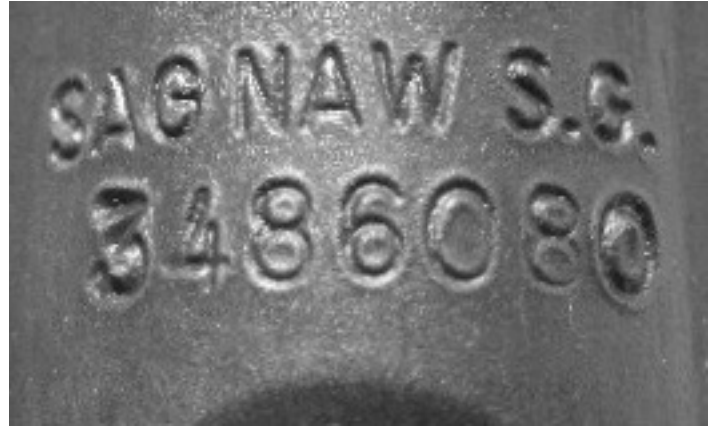
Newsletter 375 featured this photo of a SAGNAW marked carbine that Charlie Brickett had purchased from CMP. Note that there is no space for the letter I. How could this error have occurred, and how many carbines were marked this way before someone noticed?

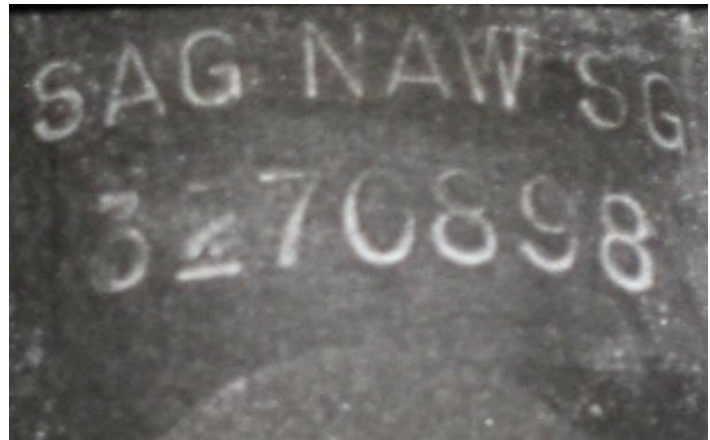
In the top example, the letter I was accidentally left out, or perhaps fell out before the letters were clamped into the jig. In the bottom example, the letter I was accidentally inserted into the jig bottom side up, leaving no impression when the jig was applied to the receiver.

Those of us who are old enough to remember “Print Shop” in high school will recall the difficulty in handling the small pieces of type-face, and clamping them into dies. Note also that two different fonts were used in the marking of these two receivers. The letters S, G, N, and W are all slightly different.

I once owned a similarly marked SG carbine, but mine had a space for the letter I. That space is smooth, with no impression from a broken-off die.

A possible explanation for both of these errors would be that Saginaw used a stamping die made up of individual “type face” letters, that were clamped together in a jig, rather than a specially-manufactured one-piece die.
